HISTORIC PRESERVATION COMMISSION
AGENDA

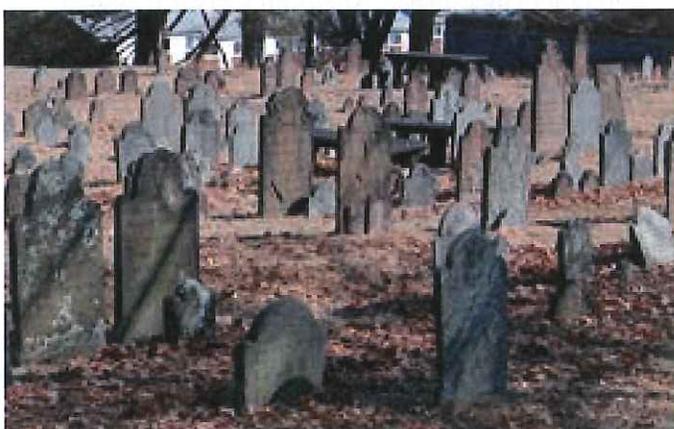
Figure 1. Sandstone and slate grave markers in the Ancient Burying Ground in New London, CT, display a variety of weathering conditions. Markers in the cemetery date from the mid-17th to the early 19th centuries. Photo: Jason Church.

While cemeteries are often considered to be perpetual, their most prominent feature—the grave markers—are not. They weather, naturally decay, often are poorly maintained and repaired and, on occasion, are vandalized (Fig. 1). Grave markers are usually noteworthy not only for their inscriptions but also for their craftsmanship. Exceptional markers are considered works of art.

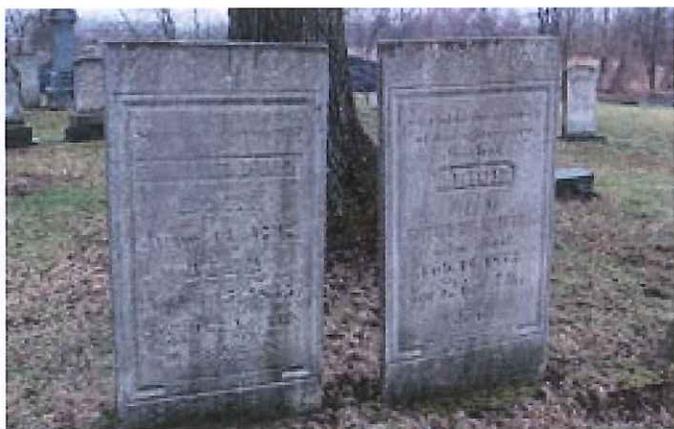
Figure 2. These mid-19th century, single-element stone grave markers in the Grove Cemetery in Bath, NY, are set in a vertical position. Photo: Jason Church.

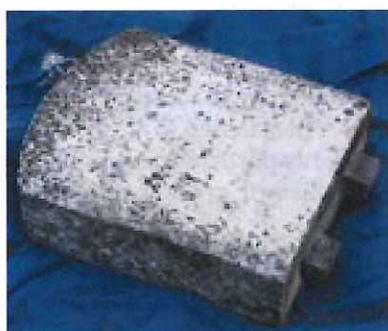
Figure 3. A multi-element grave marker from the early 19th century in the St. Michael's Cemetery, Pensacola, FL, consists of a vertical element with tabs (left image) into a slotted base (right image). Photo: Fran Gale.

slot" grave marker, the tabbed upper stone was set in a slotted base (Fig. 3). More common today, the upper headstone is secured with a technique that uses small spacers set on the base and a setting compound. This technique or one that uses an epoxy adhesive may be found on older markers where the stones have been reset.

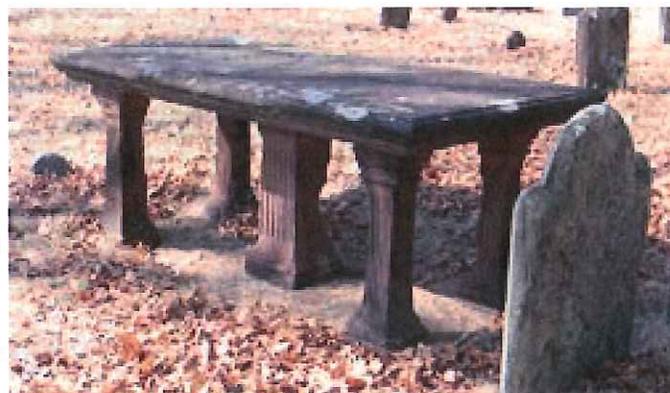
Figure 4. This sandstone table tomb, located in Cedar Grove Cemetery, New London, CT, is an engineered grave marker structure consisting of a horizontal stone tablet supported by four vertical table "legs" with and a central column. Photo: Jason Church.

Grave markers can also be engineered structures. Examples of grave marker structures include masonry arches, box tombs, table tombs, grave shelters, and mausoleums (Fig. 4). The box tomb is a rectangular structure built over the gravesite. The human remains are not located in the box itself as some believe, but

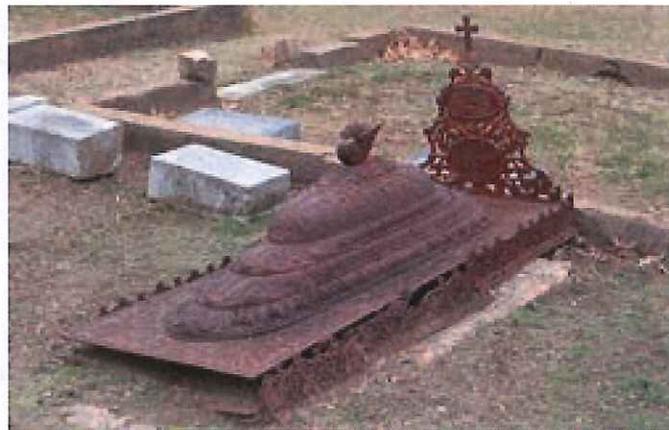
Figure 6. Decorative cast-iron grave markers like this late-19th century one in Oakland Cemetery in Shreveport, LA, are produced by heating the iron alloy and casting the liquid metal into a mold. Photo: Jason Church.

Metals are solid materials that are typically hard, malleable, fusible, ductile, and often shiny when new (Fig. 6). A metal alloy is a mixture or solid solution of two or more metals. Metals are easily worked and can be melted or fused, hammered into thin sheets, or

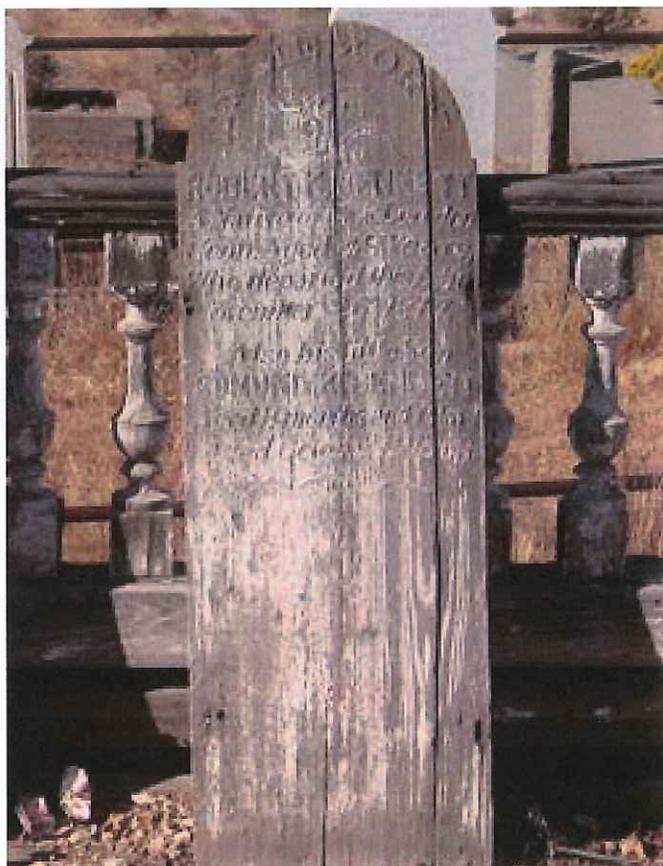
Figure 7. As shown by this 1877 marker in Silver Terrace Cemetery, Virginia City, NV, exposure to sunlight can damage wood grave markers, making the wood more susceptible to water damage and cracking. Photo: Jason Church.

and characteristics of these cells determine the wood's appearance and influence wood properties. Wood-cell walls and cavities contain moisture. Oven drying reduces the moisture content of wood. After the drying process, the wood continues to expand and contract with changes in moisture content. The loss of water from cell walls causes wood to shrink, sometimes distorting its original shape (Fig. 7).

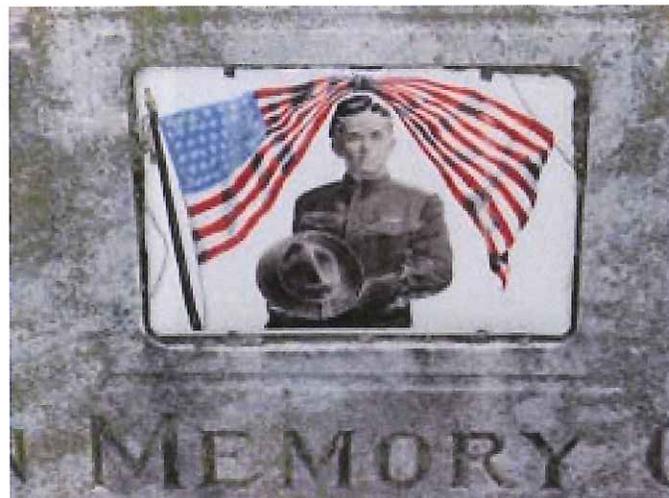
Figure 8. A fired ceramic, this cameo is set in a marble grave marker, located in Elmwood Cemetery, Memphis, TN. Different materials may require different conservation approaches. Photo: Mary Striegel.

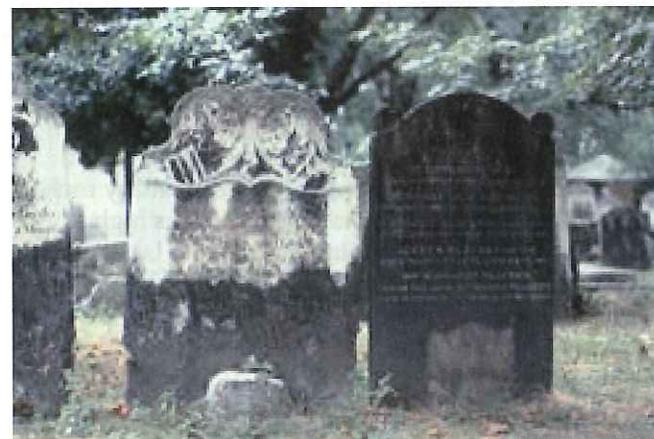
Figure 9. The limestone and sandstone grave markers in this historic cemetery have different weathering processes. On the left, the limestone shows surface loss in areas exposed to rainwater and gypsum crust formation below. The sandstone marker on the right displays uniform soiling, but surface hardening may be occurring. Photo: Fran Gale.

All grave marker materials deteriorate when they are exposed to weathering such as sunlight, wind, rain, high and low temperatures, and atmospheric pollutants (Fig. 9). If a marker is composed of several materials, each may have a different weathering rate. Some weathering processes occur very quickly, and others gradually affect the condition of materials. Weathering results in deterioration in a variety of ways. For example, when exposed to rainwater some stones lose surface material while others form harder outer crusts that may detach from the surface.

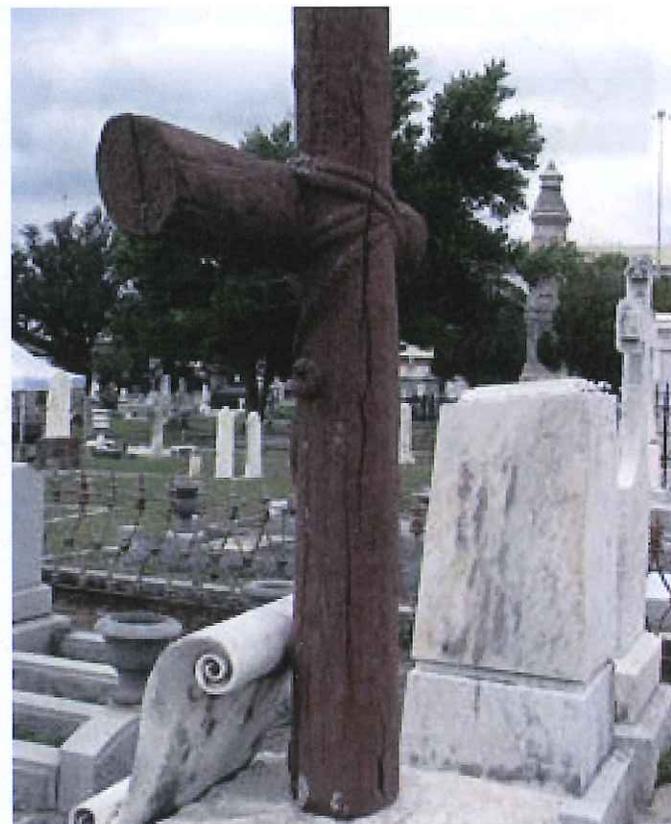
Figure 10. The sandstone cross (carved to look like wood) in this grave marker in St. Michael's Cemetery in Pensacola, FL, provides an example of inherent vice – the severe delamination affecting the sandstone has occurred along its natural bedding planes. Photo: Fran Gale.

The term "inherent vice" is used to describe a material with a naturally occurring problem that leads to premature deterioration (Fig. 10). An example of this problem is marble that has cracked due to natural locked-in stresses. Inherent vice also describes grave markers that are composed of incompatible materials, where decay is accelerated in one or both materials because of chemical interactions caused by their close proximity. An example is the galvanic corrosion that occurs when dissimilar metals, such as copper and iron, are in contact and exposed to moisture.

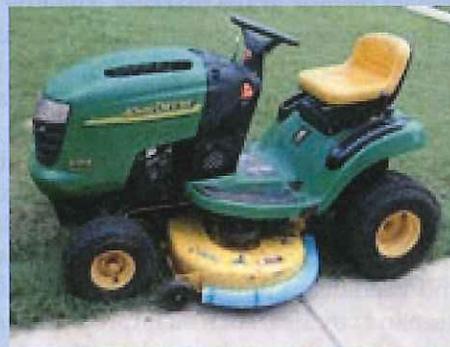
Figure B. A pool 'noodle' can be fitted to the deck of a lawnmower to prevent damage to grave markers. Photo: Debbie Dietrich Smith.

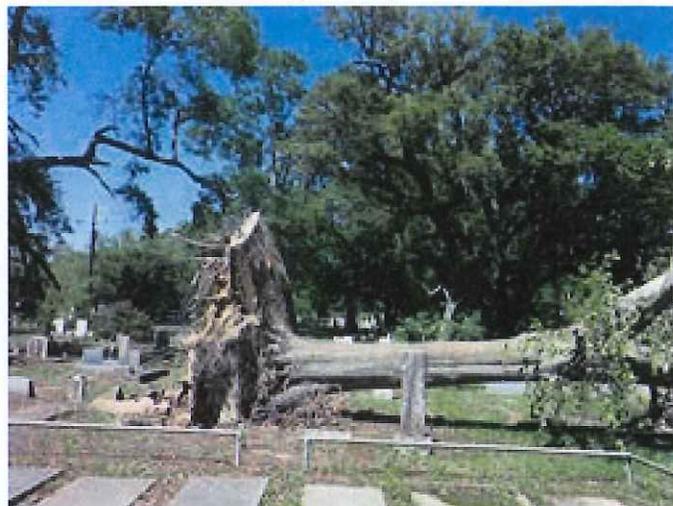
Figure 11. Woody vegetation can damage grave markers and pose a risk to visitors unless well managed and maintained. Photo: Jason Church.

Woody vegetation can damage grave markers in a variety of ways (Fig. 11). Trees, bushes, and vines can shade grave markers, extending the time that the markers are exposed to moisture. Tendrils and roots may burrow into mortar joints and openings, causing mechanical damage and large plants may lift up or shift markers. Even leaves and twigs, when allowed to collect on the ground near grave markers, can affect water drainage and evaporation (Fig. 12).

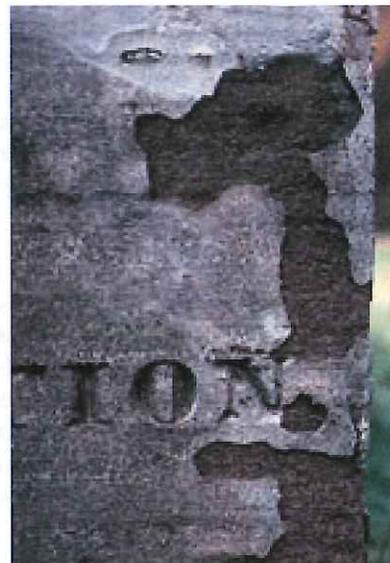
Figure 14. High-pressure water washing can damage grave markers. The photograph shows "wand marks" on the headstones produced by inappropriate pressure washing. Photo: Jason Church.

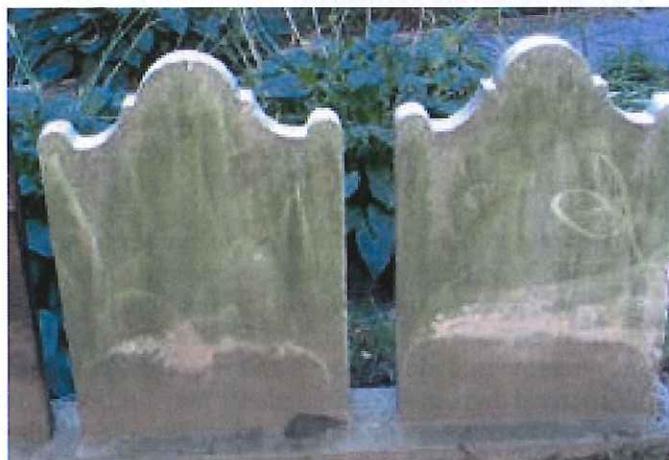
Harsh cleaning products and techniques can have a detrimental effect on grave markers. Acidic cleaners such as muriatic acid can dissolve minerals in many masonry materials and can attack metals. Alkaline cleaners, such as bleach, are notorious for leaving residual salts that are deposited on the surface (a process called efflorescence). Both acidic and alkaline cleaning can result in staining, especially if rinsing is inadequate. Using high-pressure water, above 500 to 1,000 psi, can needlessly damage materials as well, increasing their vulnerability to weathering (Fig. 14). If the marker is fragile, even low pressure water can be damaging. Techniques to avoid include aggregate blasting with sand or other harsh media and the use of power tools with abrasive wire or Nylox™ brushes.

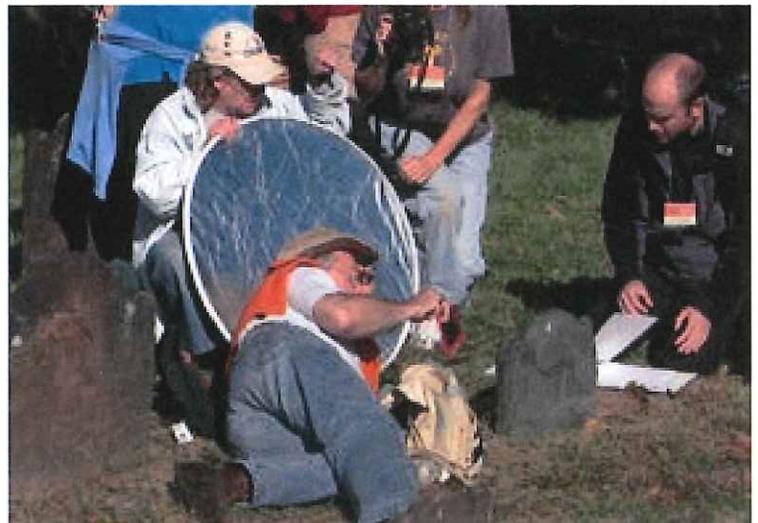
Figure 15b. Photographs are used to document the condition of the grave marker as part of a condition assessment. Photo: Fran Gale.

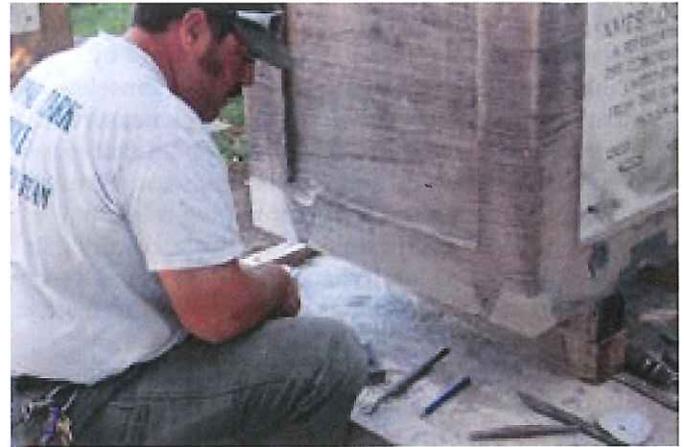
Figure 16. A professional mason works to insert a new piece of stone. Often referred to as a "dutchman", this repair technique requires replacing the deteriorated stone section with a new finished piece of the same size and material. Photo: Jason Church.

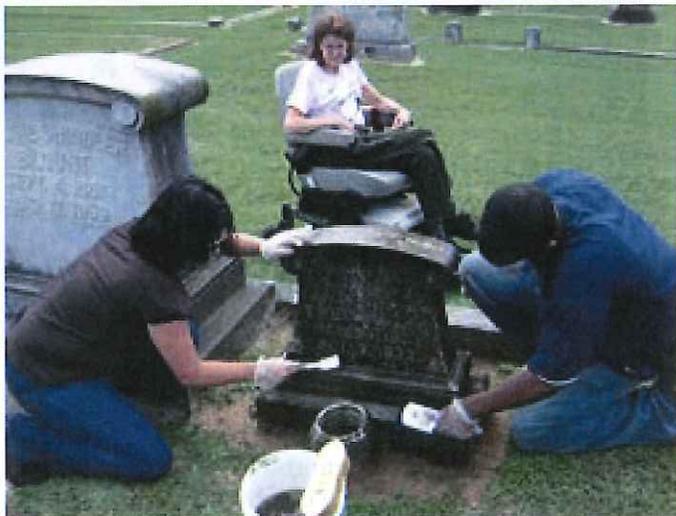
Figure 17. Volunteers can undertake cleaning of grave markers once they have received initial training. Cleaning methods may include wetting the stone, using a mild chemical cleaner, gently agitating the surface with a soft bristle brush, and thoroughly rinsing the marker with clean water. Photo: Jason Church.

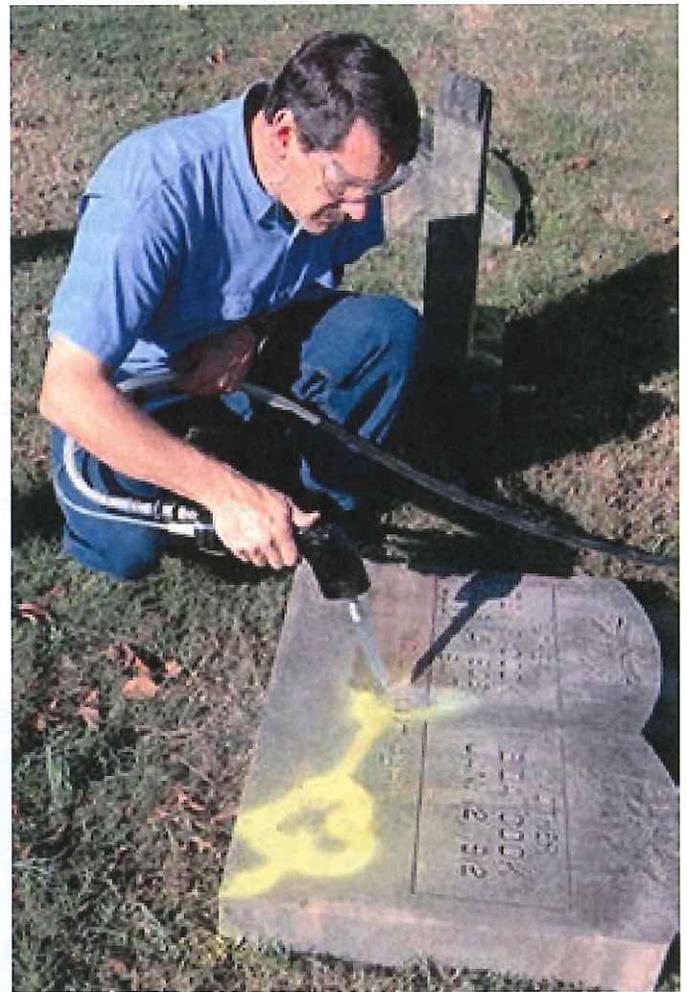
Figure 18. Graffiti is carefully removed using a low-pressure dry-ice misting instrument. Photo: Jason Church.

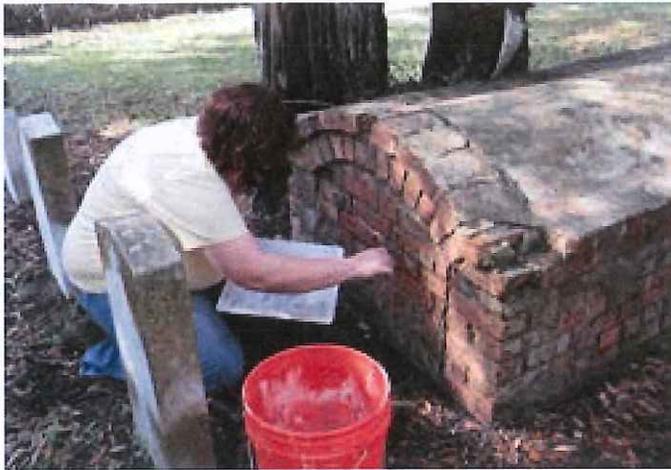
Figure 19. Masonry markers like this box tomb may require the repointing of mortar joints. It is important to use a mortar that is softer than the historic brick. In this case a conservator uses a lime putty-based mortar to repoint. Photo: Jason Church.

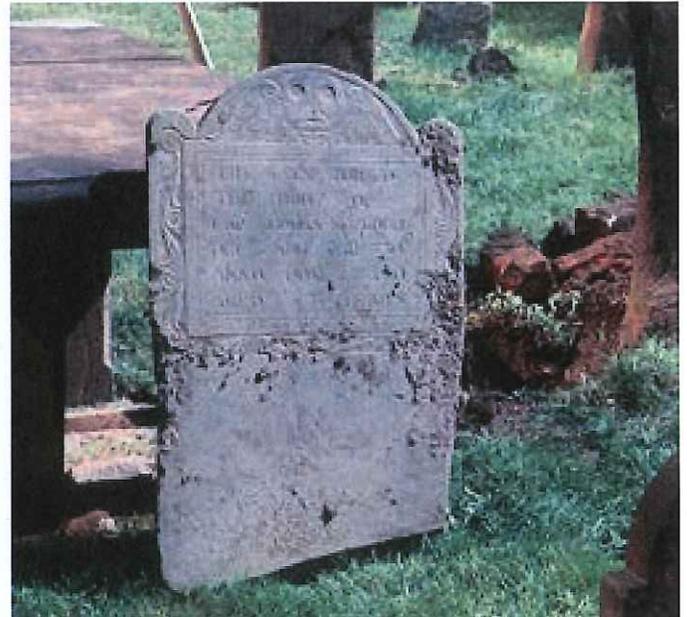
Figure 20a. This slate grave marker in the Ancient Burying Ground in Hartford, CT, is a ground-support stone. Resetting requires digging a hole that will hold the base of the stone and then compacting the soil at the bottom of the hole by hand. Photo: Fran Gale.

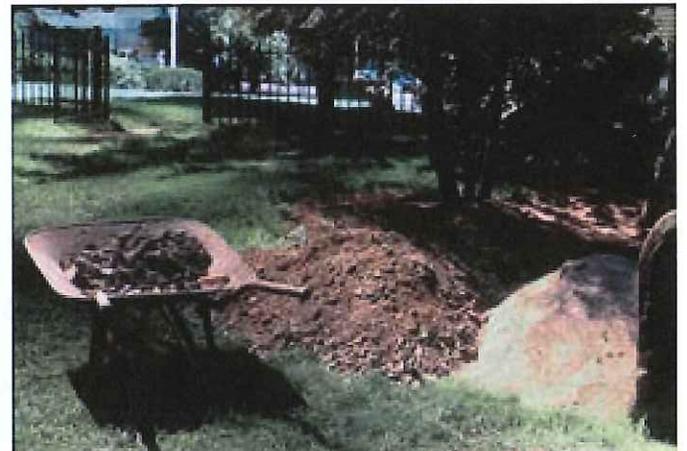
Figure 20b. To facilitate drainage, crushed stone, gravel, and sharp sand line the hole and are hand-tamped around the stone after placement. Photo: Fran Gale.

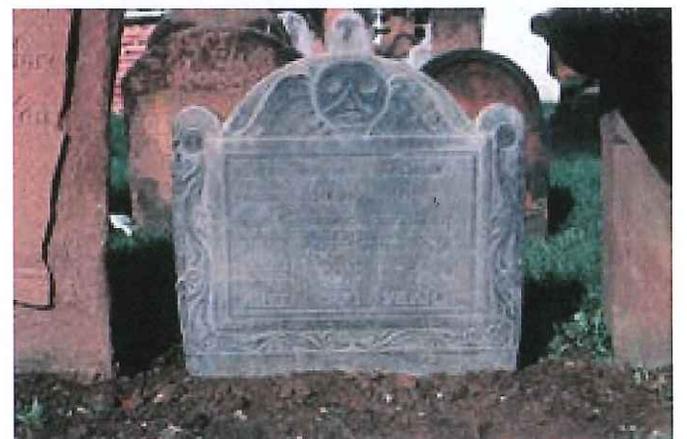
Figure 20c. The reset ground-supported grave marker should be level and plumb. Photo: Fran Gale.

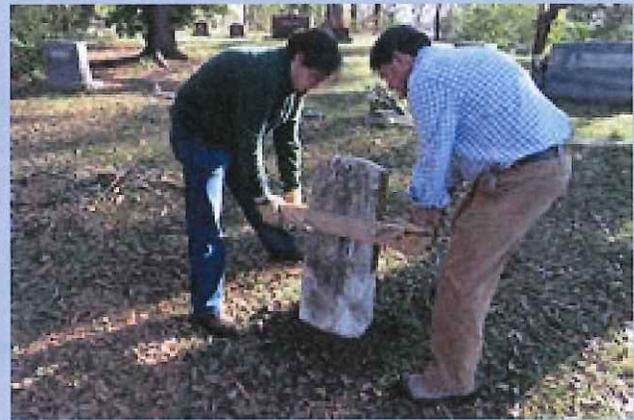
Figure E1. The simple wooden clamp system allows two people to safely lift a marble grave marker. Photo: Sarah Jackson.

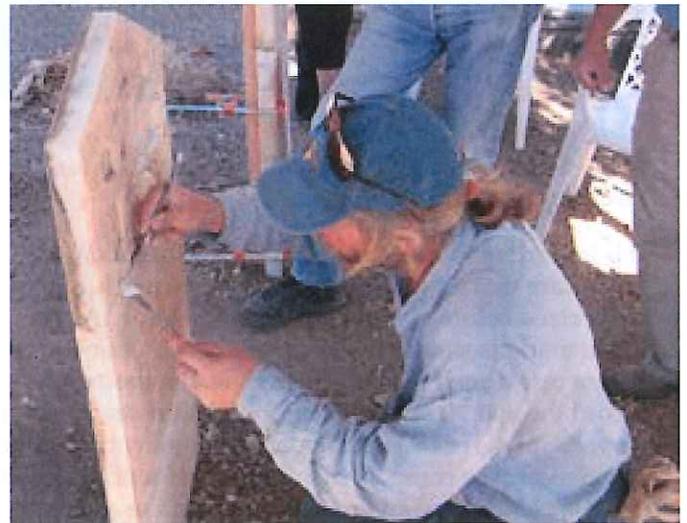
Figure 21. Cracks in a stone marker should be filled to keep water and debris out and prevent the crack from becoming larger. A patching mortar is designed to be used, in this case, with historic marble. Photo: Mary Striegel.

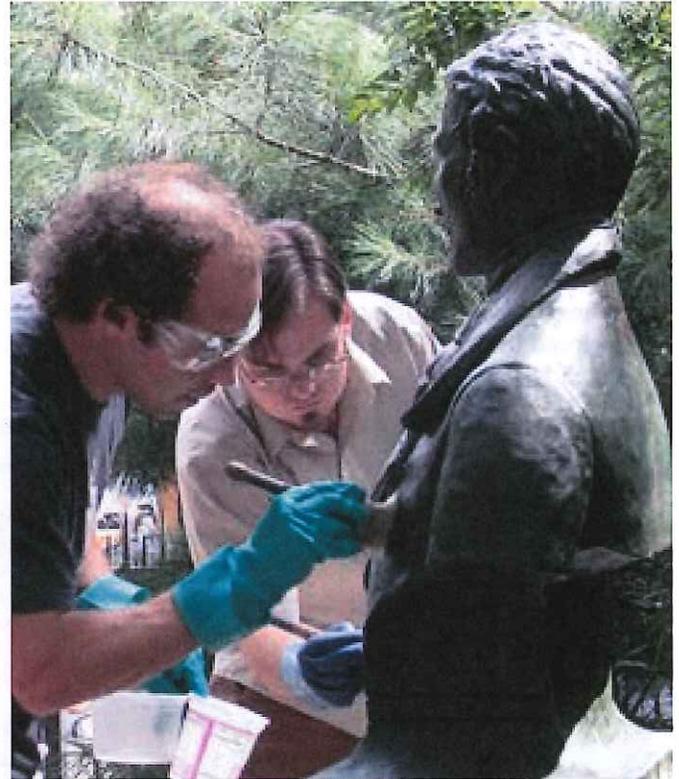
Figure 22. A protective coating must be maintained on metal elements. Wax or lacquer coatings help preserve the bronze patina and slow corrosion. Conservators apply a microcrystalline wax to this bust at St. Mark's Church in-the-Bowery, New York, NY. Photo: John Scott.

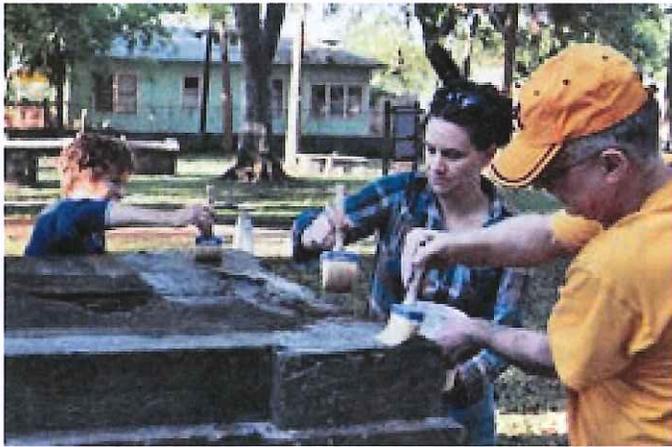
Figure 23. Limewash is a breathable coating sometimes used to protect the surface of the grave marker and provide a decorative finish. Limewash is applied by brush in five to eight thin coats (with each coat about the consistency of skim milk). The surface is allowed to slowly dry between coats. Sometimes the surface is covered by damp burlap to slow the drying process. Photo: Sarah Jackson.

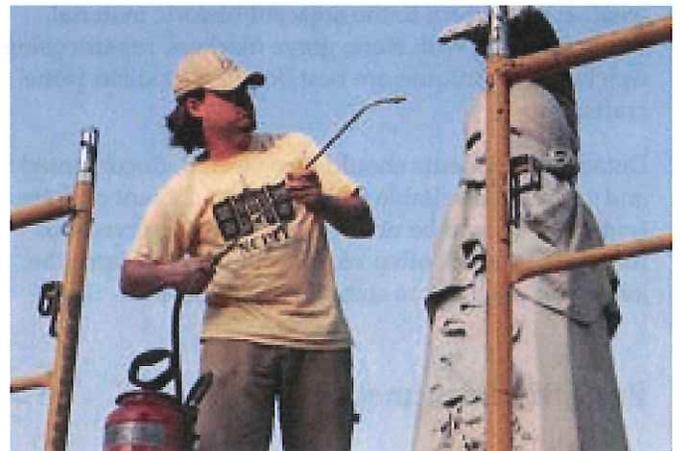
Figure 24. A severely deteriorating monument or grave marker can be treated with a stone consolidant. The treatment is usually applied using a spray system. The consolidant soaks into the stone and replaces mineral binders that hold the stone together. On-site and laboratory testing and evaluation are performed prior to using this non-reversible type of treatment. Photo: Lucas Flickinger.
